UG1 Longwalls 104 to 105

Surface water technical report

Moolarben Coal Operations Pty Ltd
0926-34-B1, 28 February 2020

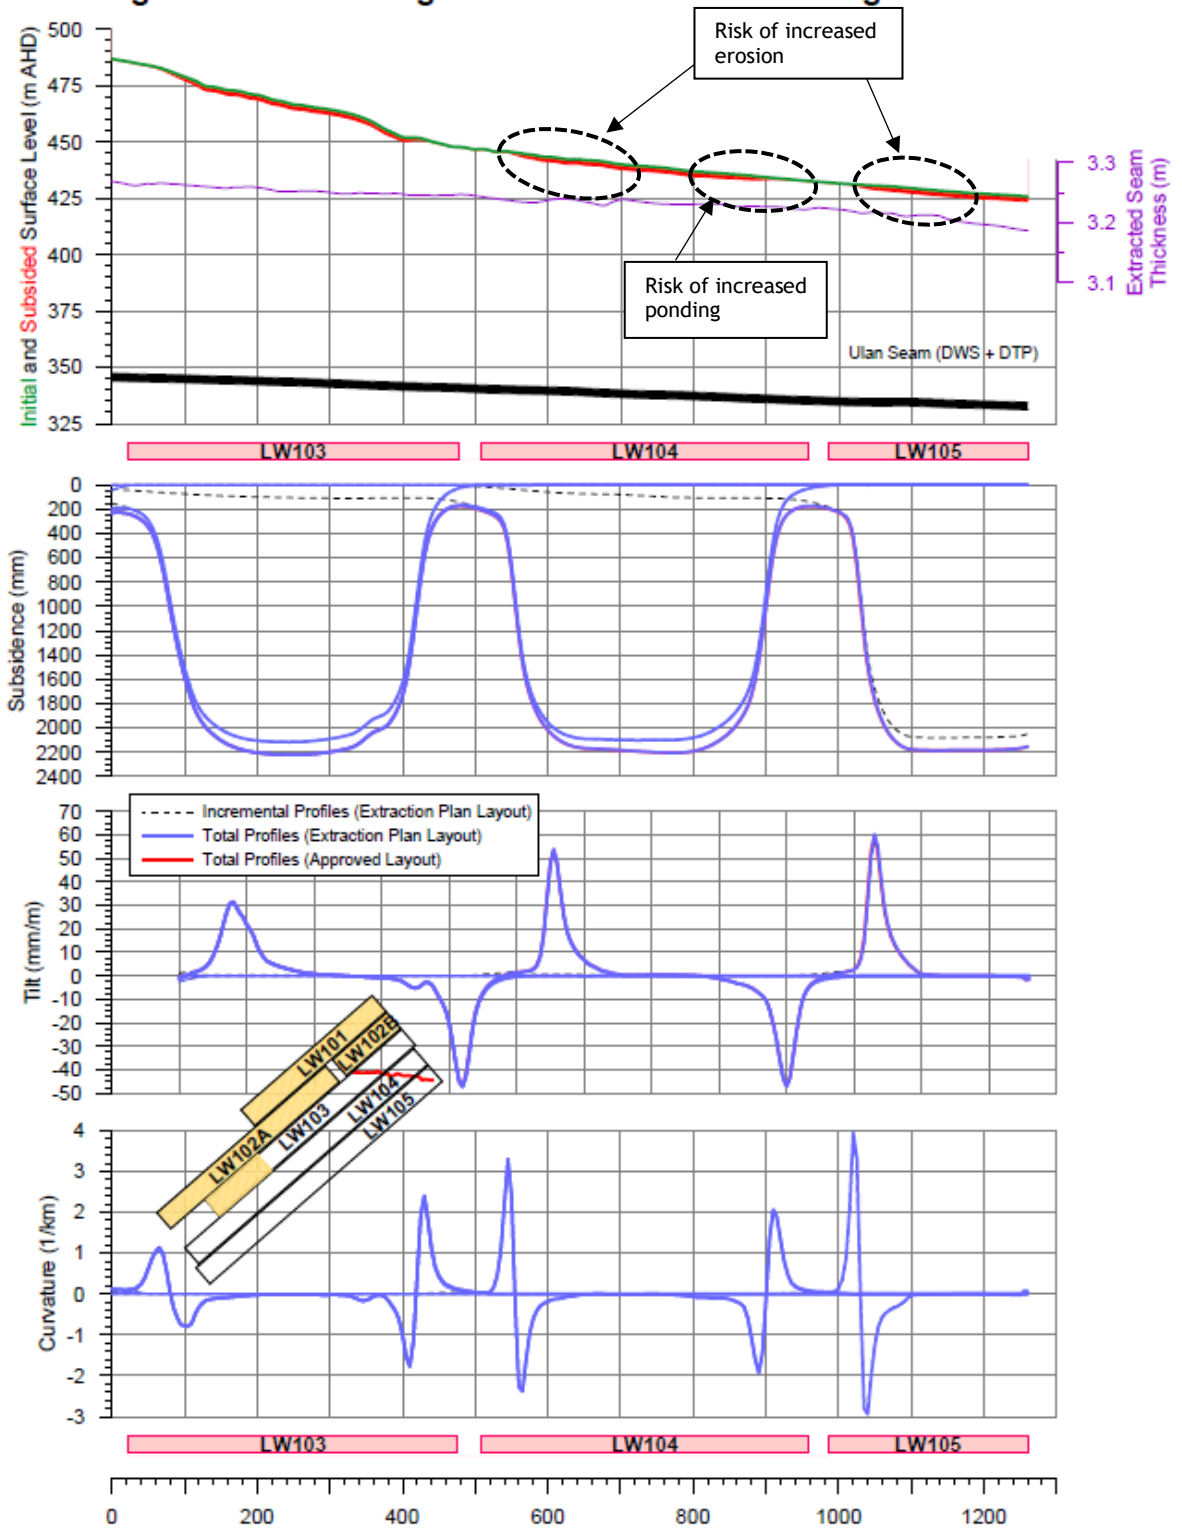
Figure 3.2 Subsidence impacts on Drainage Line 7 (Source: MSEC, 2020)

Predicted Profiles of Conventional Subsidence, Tilt and Curvature along Drainage Line 7 Resulting from the Extraction of Longwalls 101 to 105

The predicted changes in grade along the drainage lines are generally less than most of the natural grades, which vary from approximately 20 mm/m to 500 mm/m. DL6 and DL7 contain predominantly alluvial and colluvial deposits and it is expected that sections of beds downstream of the additional ponding areas may erode during subsequent rain events, especially during times of high flow. The predicted changes in grade are expected to increase the risk of erosion over a reach length of about 100 metres (m) immediately downstream of the chain pillar and increase the potential for ponding over a similar length immediately upstream of the chain pillar. The areas of DL6 and DL7 predicted to be at increased risk of erosion or ponding are shown in Figure 3.1 and Figure 3.2.
